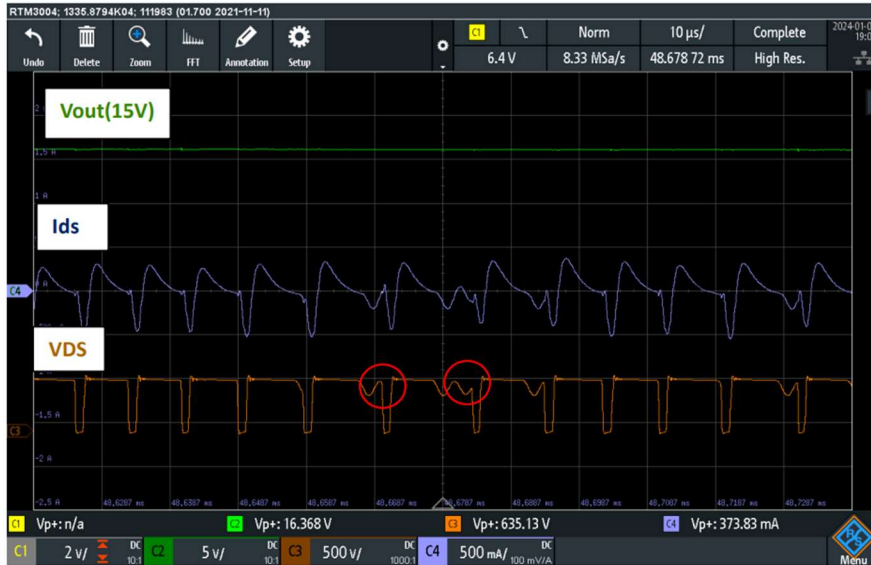
This is not double switching. This means that the TRF is now operating in discontinuous mode.

There is something wrong in the IDS waveform. I have not encountered this IDS waveform. Please check your set up.

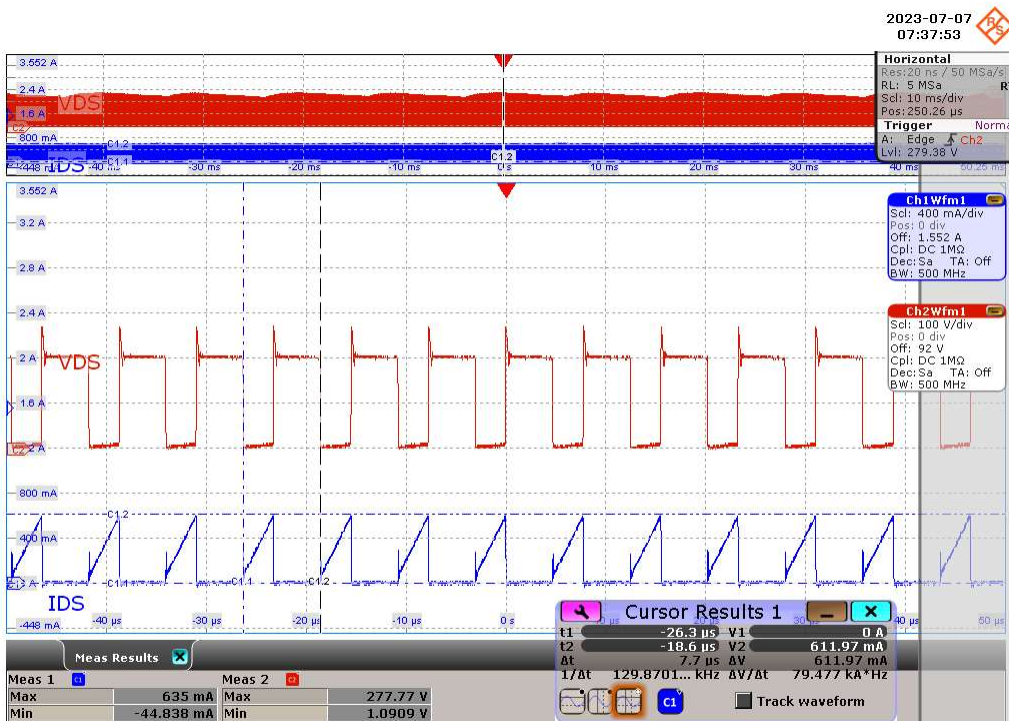
Correct IDS waveform is show below.
